Widening of the Elche de la Sierra Arch Bridge, Spain

Peter Tanner, Civil Engineer, Cesma Ingenieros, Madrid, Spain; Juan Luis Bellod, Civil Engineer, Cesma Ingenieros, Madrid, Spain

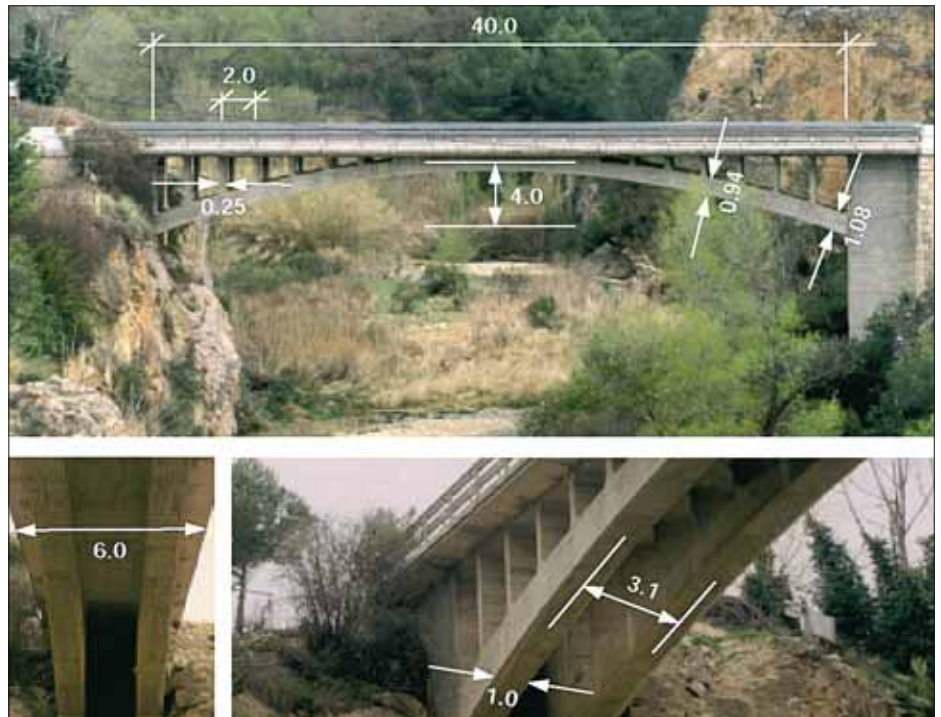
Fig. 1: Existing bridge

quarterpoint. The axis of each arch follows a parabola with a ratio of arch span, to rise of 1/10 (Fig. 1). Like the arch, the support walls of the roadway girder are 1,0 m wide. Measuring 0,25 m thick, they are spaced at an interval of 2,0 m from centreline to centreline. The deck girder, a double-ribbed, reinforced concrete slab, and the arches are connected monolithically at the crown. The abutments are constituted by walls designed to receive the thrust transmitted by the arches. In all, the structure including the accesses is 71,6 m long.

The 40 m span arch bridge at Elche de la Sierra in the Spanish province of Albacete was built in 1927. It was based on the ideas and guidelines of the renowned engineer Eugenio Ribera (1864–1936), which had been compiled in an official standard on arch bridges. The Segura River is spanned by a twin arch, the two ribs being separated by a distance of 3,1 m. Each of these ribs is 1,0 m wide with a depth varying from 1,08 m at the springing to 0,94 m at the

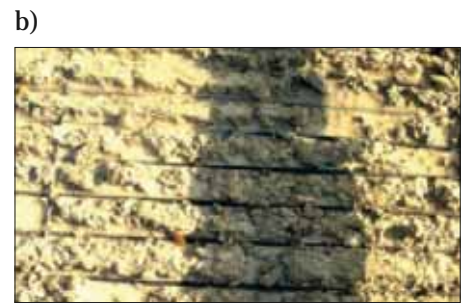
- The concrete cover was to be removed in a way such as to ensure that, after the widening of the deck, the upper layer of the existing transverse reinforcement was embedded in the new concrete (Fig. 3b). In this way, a mechanical connection between the two concretes was achieved by means of the existing reinforcement. The concrete cover was only to be removed in strips 1,5 m wide on both sides of the deck slab (Fig. 3a), that is in the areas of maximum longitudinal shear forces due to the combined global action effects and transverse bending moments.
- A bonding layer was to be applied to the surface where the two concretes are in contact.
- A concrete with reduced shrinkage strain was to be used to widen the deck slab.
- Reinforcement was to be placed as required to control cracking in the new concrete.

Fig. 3 b): Transverse reinforcement on the existing deck slab

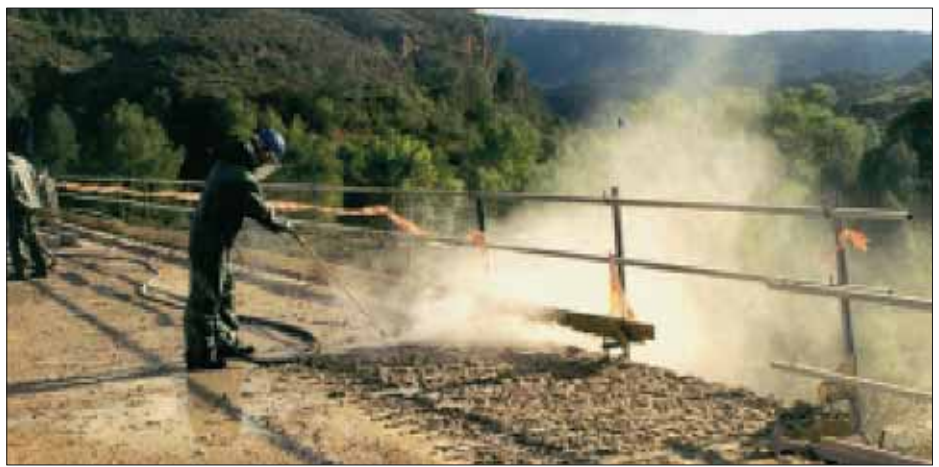
Fig. 5: Hydrodemolition of the existing concrete cover

The construction procedure adopted to implement the structural solution described above in the section "Planned Intervention" was quite simple. After removing the surface course and demolishing the imposts on the existing bridge, the concrete cover was removed down to the transverse reinforcement in strips 1.5 m wide along the edges of the existing slab, to contribute to the bonding between the existing and new concretes. For this purpose, hydrodemolition techniques were used (Fig. 5) to protect the existing structure from possible damage.

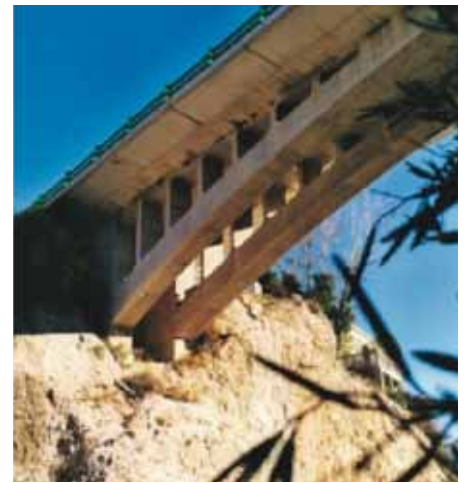
Simplicity of the structural solution and adopted construction procedure made it possible to complete the enlargement work on schedule (Fig. 6). Substantiation of the fact that the

Fig. 6: Bridge over the Segura River at Elche de la Sierra after the widening (Photograph: Paco Gómez)
